*Ice force measurements on a bridge pier in the  
Ottauquechee River, Vermont*

# CRREL Report 83-32

December 1983

D.S. Sodhi, K. Kato and F.D. Haynes

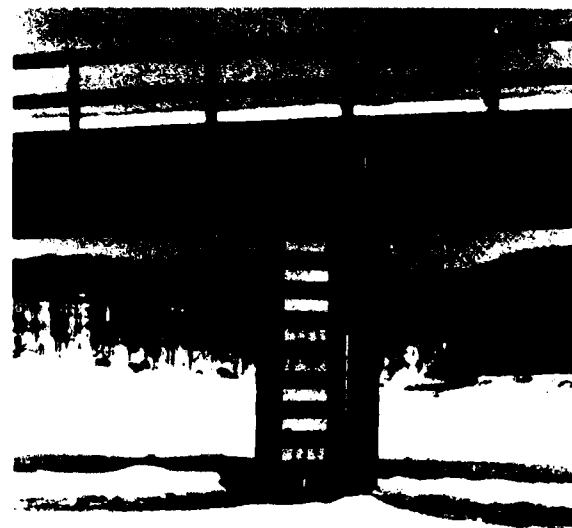
Figure 1. Load panels on the bridge pier in the Ottawa-Quechee River near Quechee, Vermont.

In this report, we present the procedure adopted for the force measurement at a bridge pier in the Ottauquechee River, Quechee, Vermont. The site is 20 miles from Hanover, New Hampshire, in a steep, shallow river typical of this region. For the measurement of ice forces, we installed four panels, two on each side of the vertical V-shaped pier as shown in Figure 1. Each panel is supported by four pins that are internally instrumented to measure forces in the normal and tangential directions. The ice forces measured on 26 March 1982 during an ice run are presented along with water level variations. We also present some data on the ice thickness and strength.

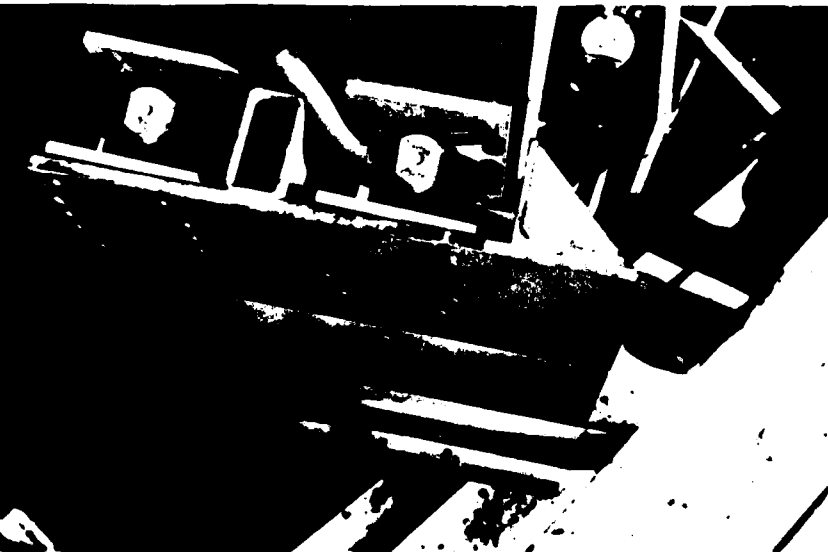
*Figure 5. Instrumented pins and the cables running behind steel plates.*

checked for any leakage. They were further protected from ice by running them behind the steel plates as shown in Figure 5.

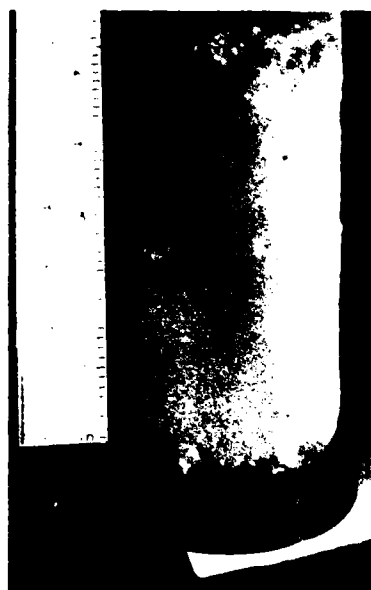
Figure 10. Specimen for the compressive strength test.

Some ice was brought to the laboratory and stored in a freezer for later measurement of compressive strength. Specimens (Fig. 10) were prepared from those ice blocks. The results of compressive strength tests conducted at  $-1^{\circ}\text{C}$  ( $30^{\circ}\text{F}$ ) are given in Table 1. Although the number of tests conducted is limited, the compressive strength of ice was in the range of 1.57 to 2.67 MPa (228 to 388 lb/in.<sup>2</sup>).
